**IN THE UNITED STATES DISTRICT COURT
FOR THE SOUTHERN DISTRICT OF TEXAS
CORPUS CHRISTI DIVISION**

HERB LANCASTER, ET AL. § **CIVIL ACTION NO. 2:17-CV-00293**

**UTILITY SERVICE CO., INC., ET
AL.** § **JURY DEMANDED**

**PLAINTIFFS' RESPONSE IN OPPOSITION TO
TANKEZ'S MOTION FOR SUMMARY JUDGMENT/MOTION TO DISMISS**

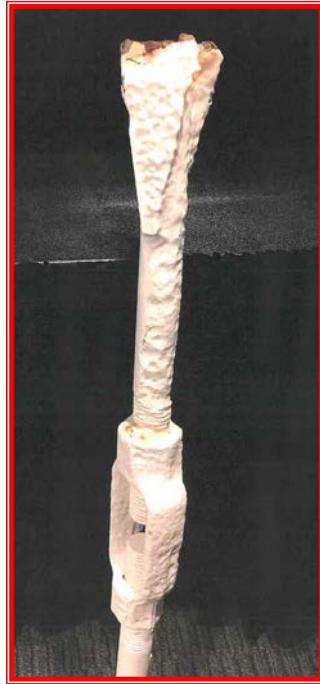
The photographs below depict the horrific condition of typical Wind Rods from the collapsed water tower [Affidavit of Travis Wells, PE, Attachment “D”]:

DILAPIDATED WIND ROD

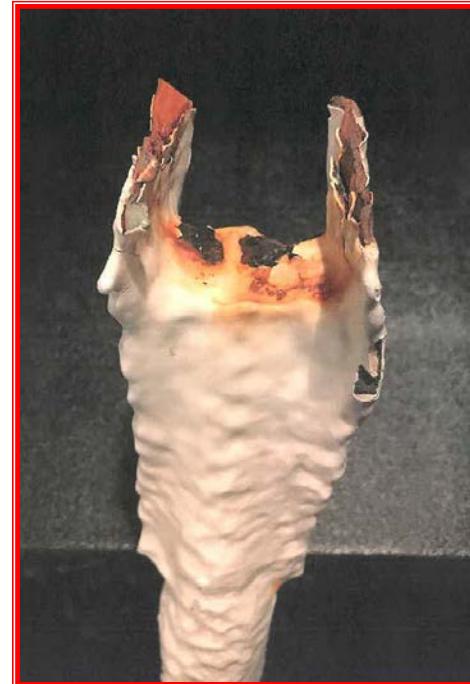
DILAPIDATED WIND ROD CLEVIS
